# Snow Avalanches of the Wasatch Front

By R. I. PERLA

ENVIRONMENTAL GEOLOGY OF THE WASATCH FRONT, 1971

UTAH GEOLOGICAL ASSOCIATION PUBLICATION 1-0

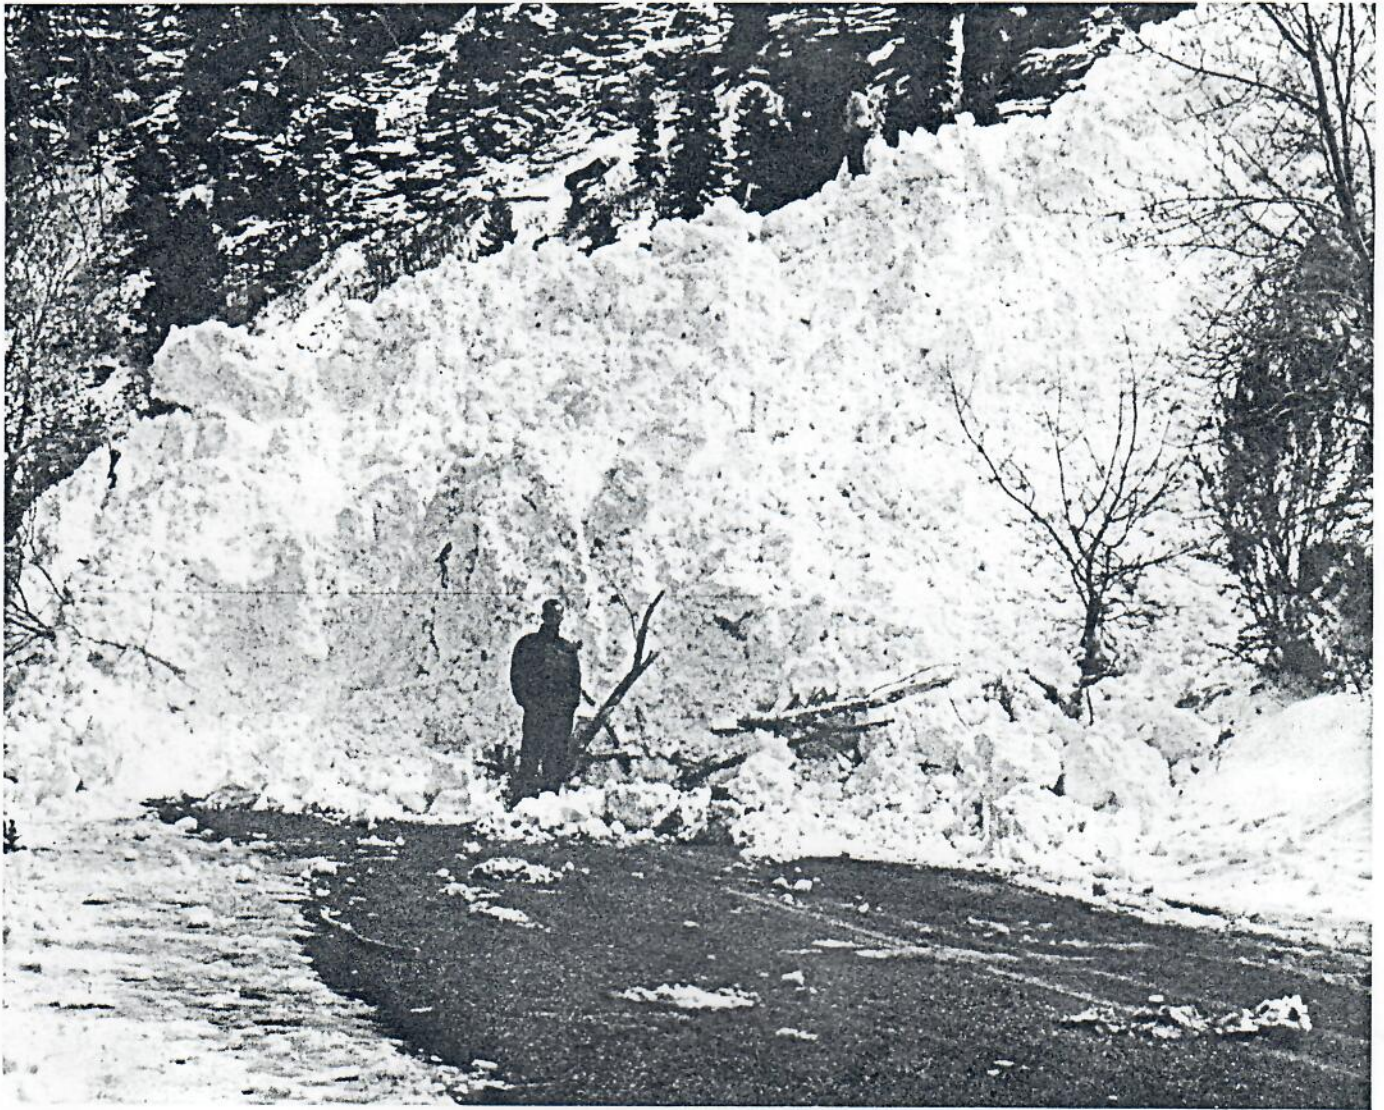
Figure 4.—Avalanche on Little Cottonwood Canyon road, at foot of Tanner Gulch, January 1965.

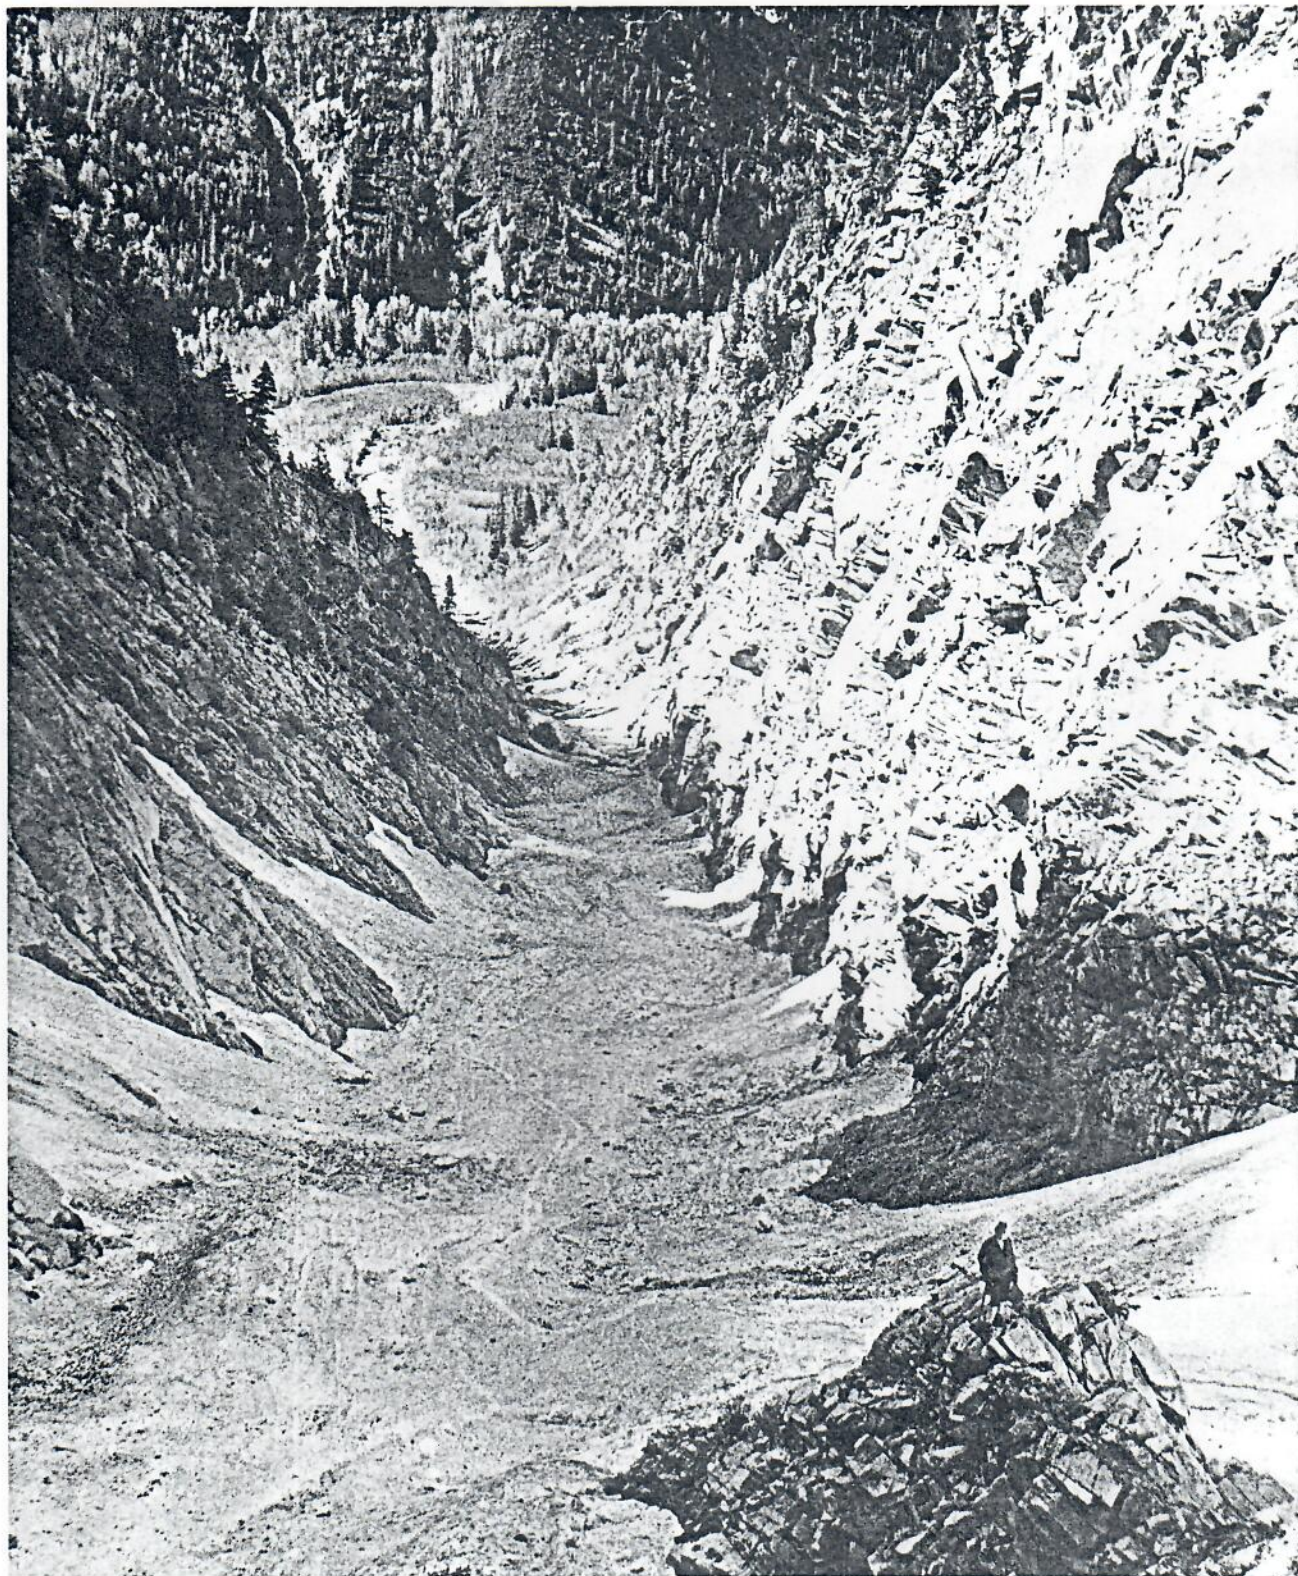
Figure 5.—View down avalanche zone of Tanner Gulch, Little Cottonwood Canyon. Barren path through young aspen growth beyond gulch defines the runout zone to where it crosses road in canyon bottom.

An avalanche zone consists of three subzones: The *starting zone*, the *track*, and the *runout-damage zone* (fig. 5). Starting zones are high, steep mountain faces where the initial snow failure takes place. Dangerous avalanches originate on slopes which have an inclination from 30° to 50°. Above 50°, the slope is too steep to accumulate large amounts of snow.

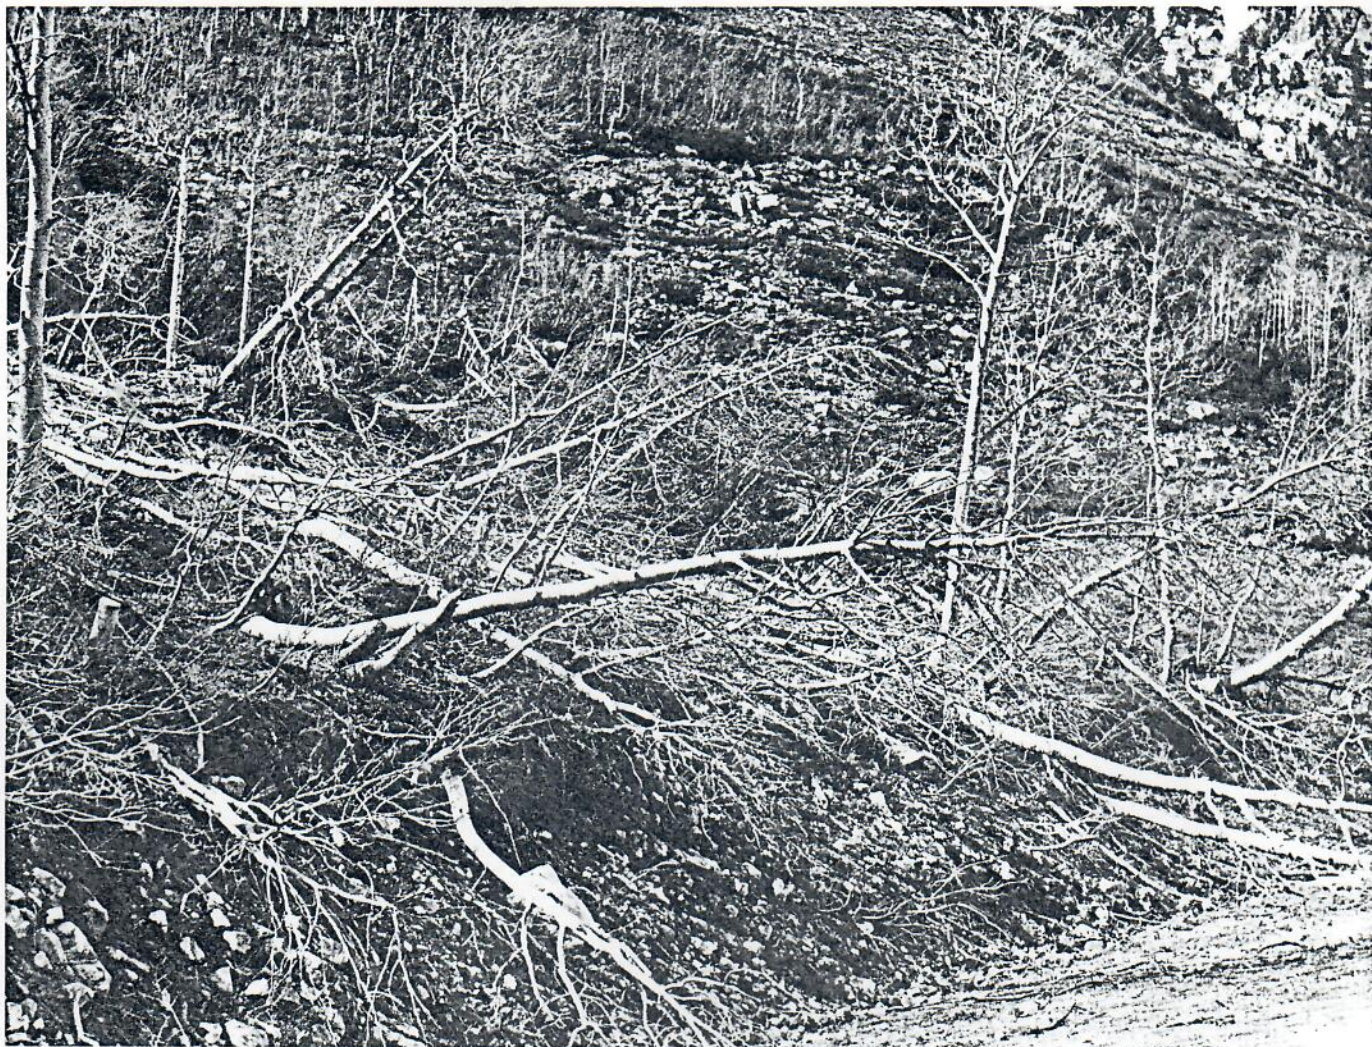
Figure 6.—Destruction of young aspen trees from avalanche off south buttress of Superior Peak. Trees are prevented from maturing by repetitive avalanches.

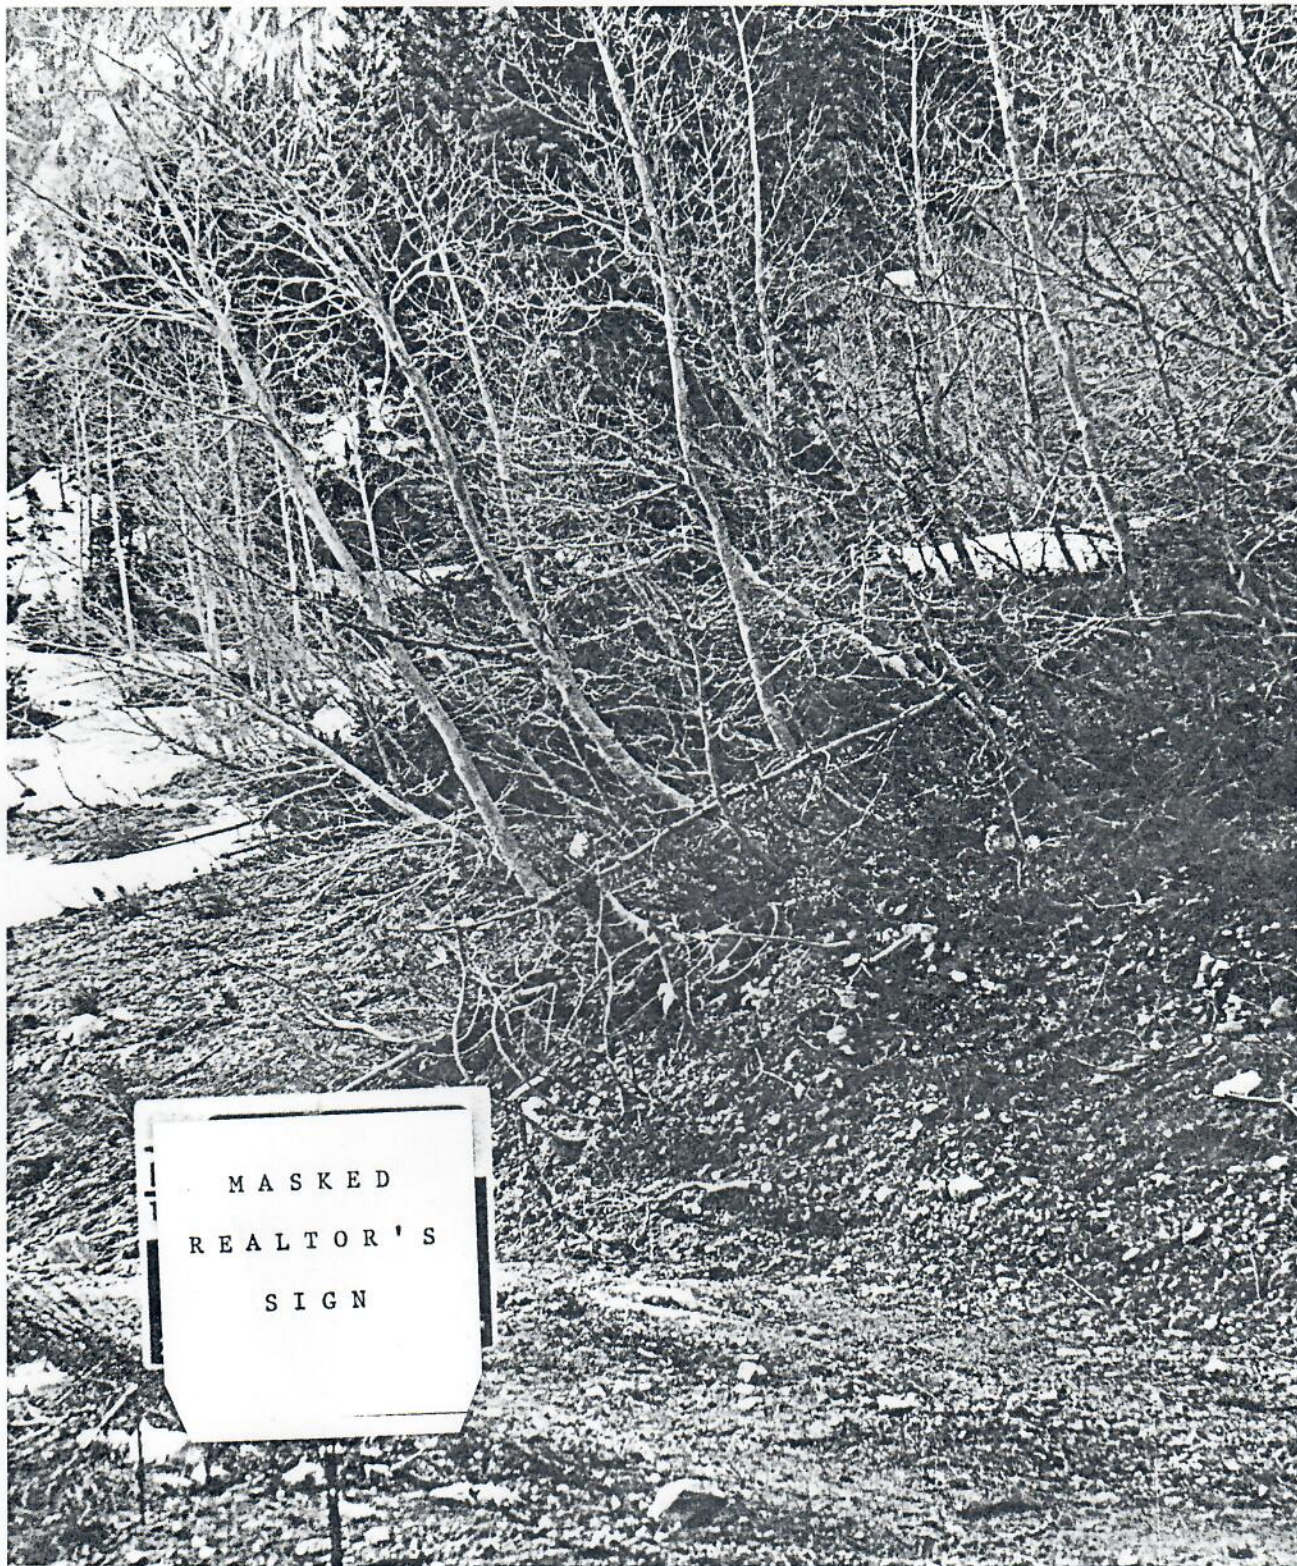
Figure 7.—Young aspen trees at base of avalanche path, Wasatch canyon area. These trees are younger than 25 years, indicating destruction of previous growth. Realtor's sign promotes land sale presumably for building development.

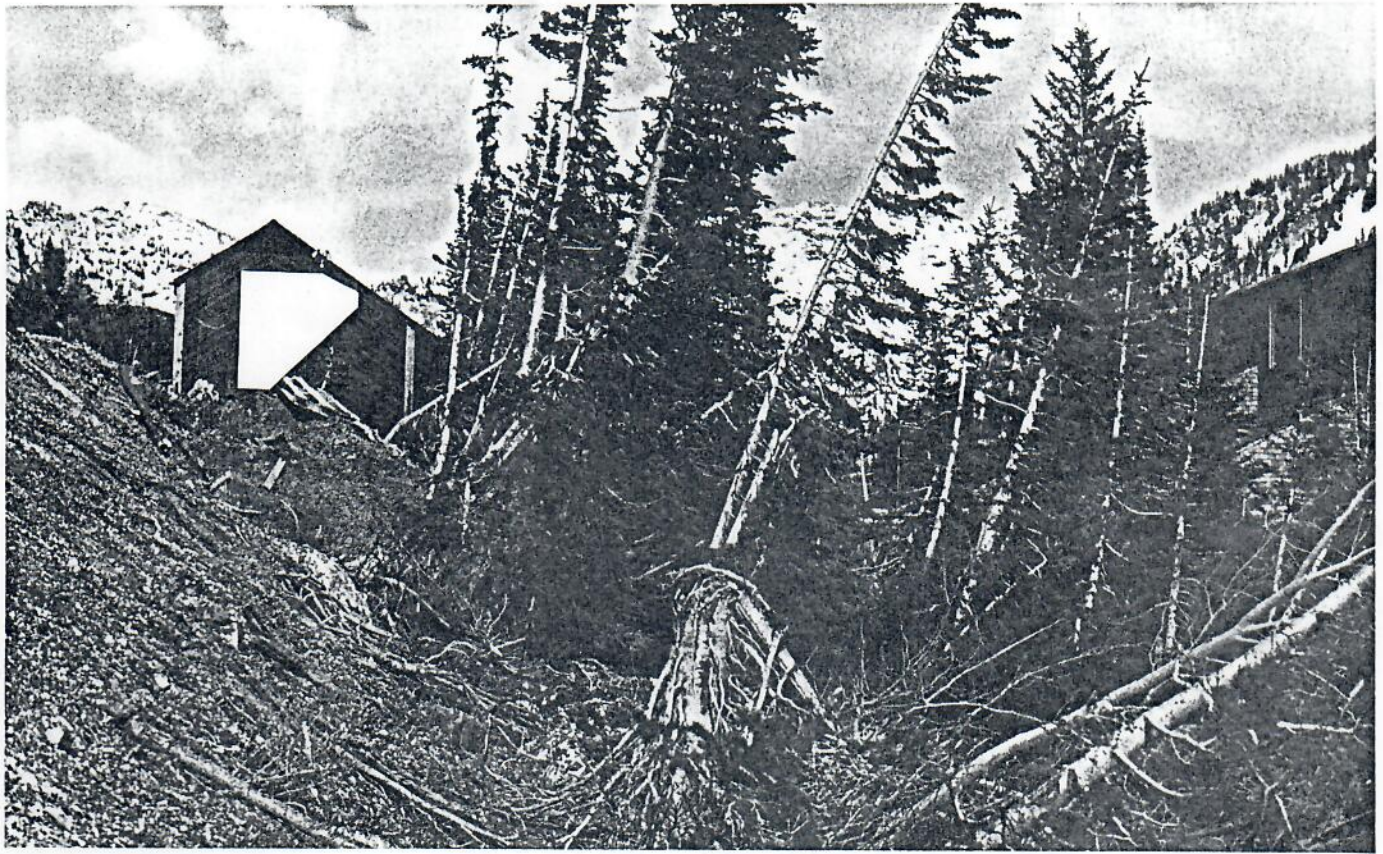
Figure 8.—Avalanche damage to alpine firs near commercial development. Larger trees may be as much as 100 years old. Note severe damage on uphill, left side, of mature trees.

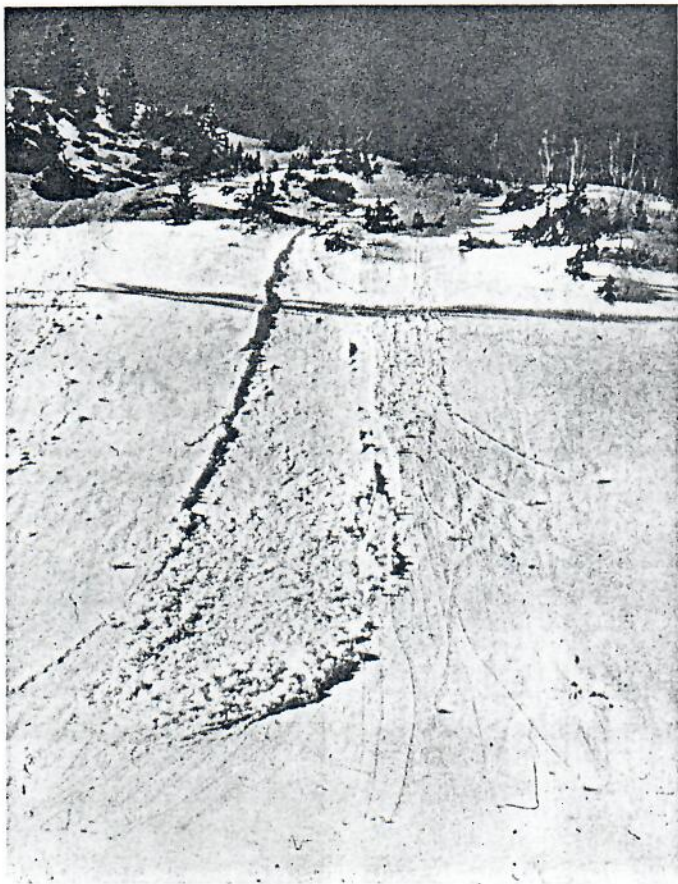
Figure 12.—A point avalanche, Alta, Utah. Note how avalanche mass widens downslope from point at top.

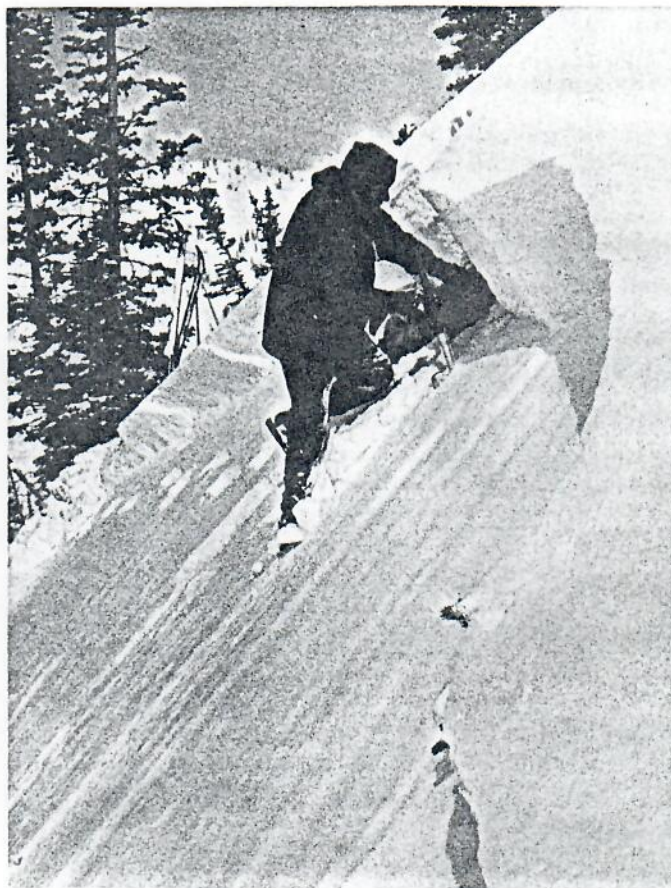
Figure 13.—Fracture face at the head of a slab avalanche. Note the angular break at head and flat glide surface where man is kneeling.

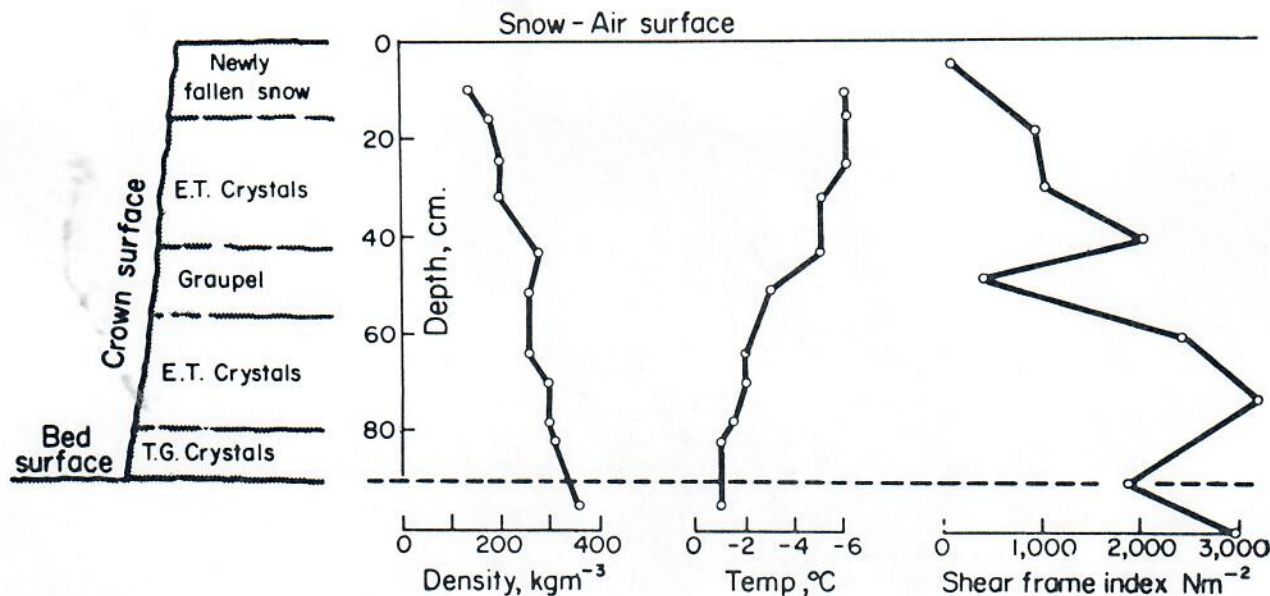
Figure 16.—Density, temperature, and shear relations within the strata of an avalanche slab at Alta, Utah.

Figure 16 illustrates the stratification of a slab which was released by Forest Service artillery at Alta, Utah. Note that the failure surface consisted of temperature-gradient (abbreviated T.G.) metamorphosed crystals, while the bulk of the slab consisted of equitemperature (E.T.) metamorphosed crystals. The T.G. crystals were formed during a clear weather period in November and December following an early October storm. As shown in the temperature profile of figure 16, temperature gradients were reduced at the time of observation, December 27, owing to the increased thickness of the slab. The center of the slab contained a notably weak layer of *graupel* crystals, which are haillike pellets that form during frontal passage of a severe storm. These spherical-shaped crystals resist metamorphism and tend to retain their original form for relatively long periods. As shown by the *shear frame index*, which is a measure of strength determined by a boxlike instrument, both the graupel and T.G. layers were possible slide surfaces (in fact, several other avalanches on December 27 slid on the graupel instead of the T.G. layer). How-

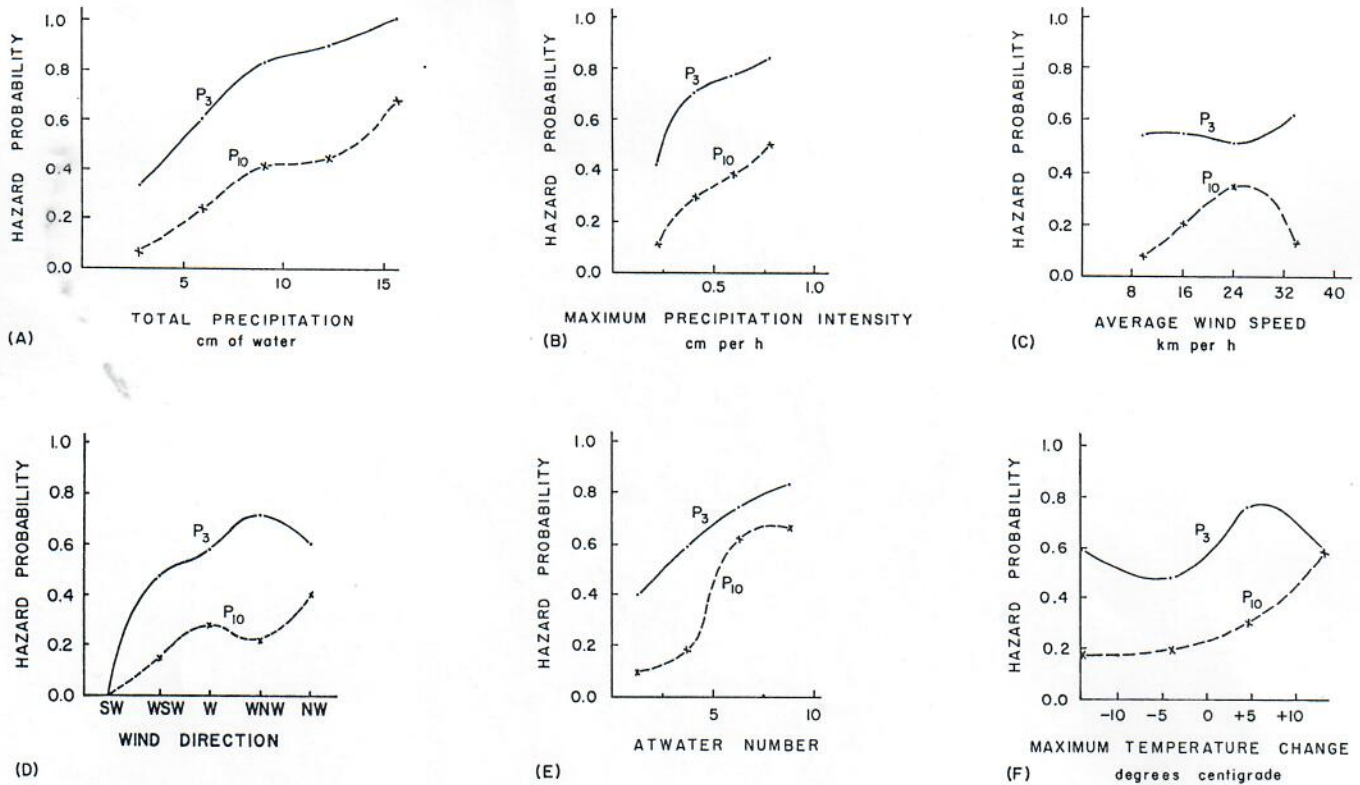
Figure 17.—Curves showing the hazard probabilities of two avalanche sizes ( $P_3$ ,  $P_{10}$ ) as related to six different storm conditions in the Alta-Little Cottonwood Canyon road area.

$P_3$ , and the probability of a major hazard,  $P_{10}$ . These hazard probabilities are defined in the following way:  $P_3$  is the probability that at least one avalanche of size 3 will run into the road-village vicinity;  $P_{10}$  is the probability that several avalanches, whose various sizes total 10, will run into the road-village vicinity. Figure 17 shows how  $P_3$  and  $P_{10}$  vary with six storm factors: (1) Total precipitation during the storm period (fig. 17A), (2) maximum precipitation intensity (fig. 17B), (3) average wind speed (fig. 17C), (4) wind direction (fig. 17D), (5) Atwater Number (fig. 17E), and (6) maximum temperature change (fig. 17F).

As shown in figure 17A, both  $P_3$  and  $P_{10}$  increase steadily with the total precipitation of the storm. In most cases, precipitation was measured by weighing a cylindrical sample of snow that was extracted manually from the new snow layer. Hazard probability could also be related approximately to total snowfall of the storm by recalling from earlier remarks that a 10-cm thickness of Wasatch snow has a water content of about 1 cm. The certainty of minimum avalanche activity ( $P_3 = 1.0$ ) at large amounts of total precipitation (or large amounts of total snow) confirms that major storms can force avalanches irrespective of the structure of the snowpack.

As shown in figure 17B, the alpine snowpack is sensitive to the maximum precipitation intensity, or the maximum rate of loading of the storm. This sensitivity was verified in the laboratory by Kinoshita (1967) who subjected snow samples to compression at various loading rates. At low rates of load application, the snow samples

As shown in figure 17C, hazard probability cannot be related definitely to wind speed, but this statement must be immediately qualified. What the storm reports indicate is that the large avalanches, which are threats to the road and village, are insensitive to wind speed, presumably because Wasatch storms most always occur with the minimum wind required to induce avalanche activity. However, it is an observed fact that small avalanche paths, which, for example, are threats within ski areas, can be loaded by strong winds that redistribute the snow, even when the measured amounts of new snow are comparatively sparse. Then, too, the data of figure 17C were derived from a low elevation anemometer (elev. about 3,300 m), which may only partly describe conditions in the high elevation starting zones (3,700 m). Recently, wind instrumentation was installed on a high elevation ridge above Alta, so that the results of figure 17C may be overruled in a revised study.

As shown in figure 17D, wind direction, in contrast to wind speed, seems to be the most reliable predictor of avalanche development on the south-facing slopes of this study. Large avalanches simply do not form on a given group of slopes unless the wind direction is favorable. By favorable is meant that the wind blows over the ridge crest as shown in figure 18.

In figure 17, parts *A, B, C,* and *D* relate the hazard probability to individual storm factors. An important problem in avalanche technology is to somehow synthesize such factors into a combined parameter. One such combined parameter is the Atwater Number which has a numerical value equal to the centimeters of water that have been deposited during a continuous period in which the rate of precipitation was above 0.25 cm/hr and the winds were above 20 km/hr. Although the critical values of 0.25 cm/hr and 20 km/hr were chosen by Atwater (1952) on the basis of limited data and some arbitrariness, nonetheless, figure 17*E* shows that the Atwater Number, as originally proposed, is a meaningful indicator of major avalanche cycles. In retrospect, the instability of the large avalanche paths which affect the Alta road and village may be better described by basing the Atwater Number on wind direction instead of speed.

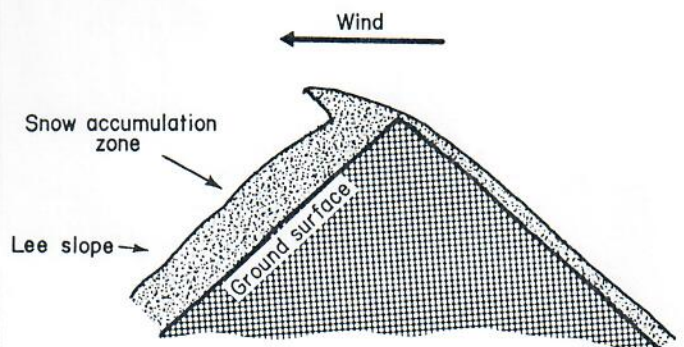
Figure 18.—Avalanche relations to a ridge, wind direction, and relative snow depths. Maximum depth is on lee side of wind and is most hazardous.

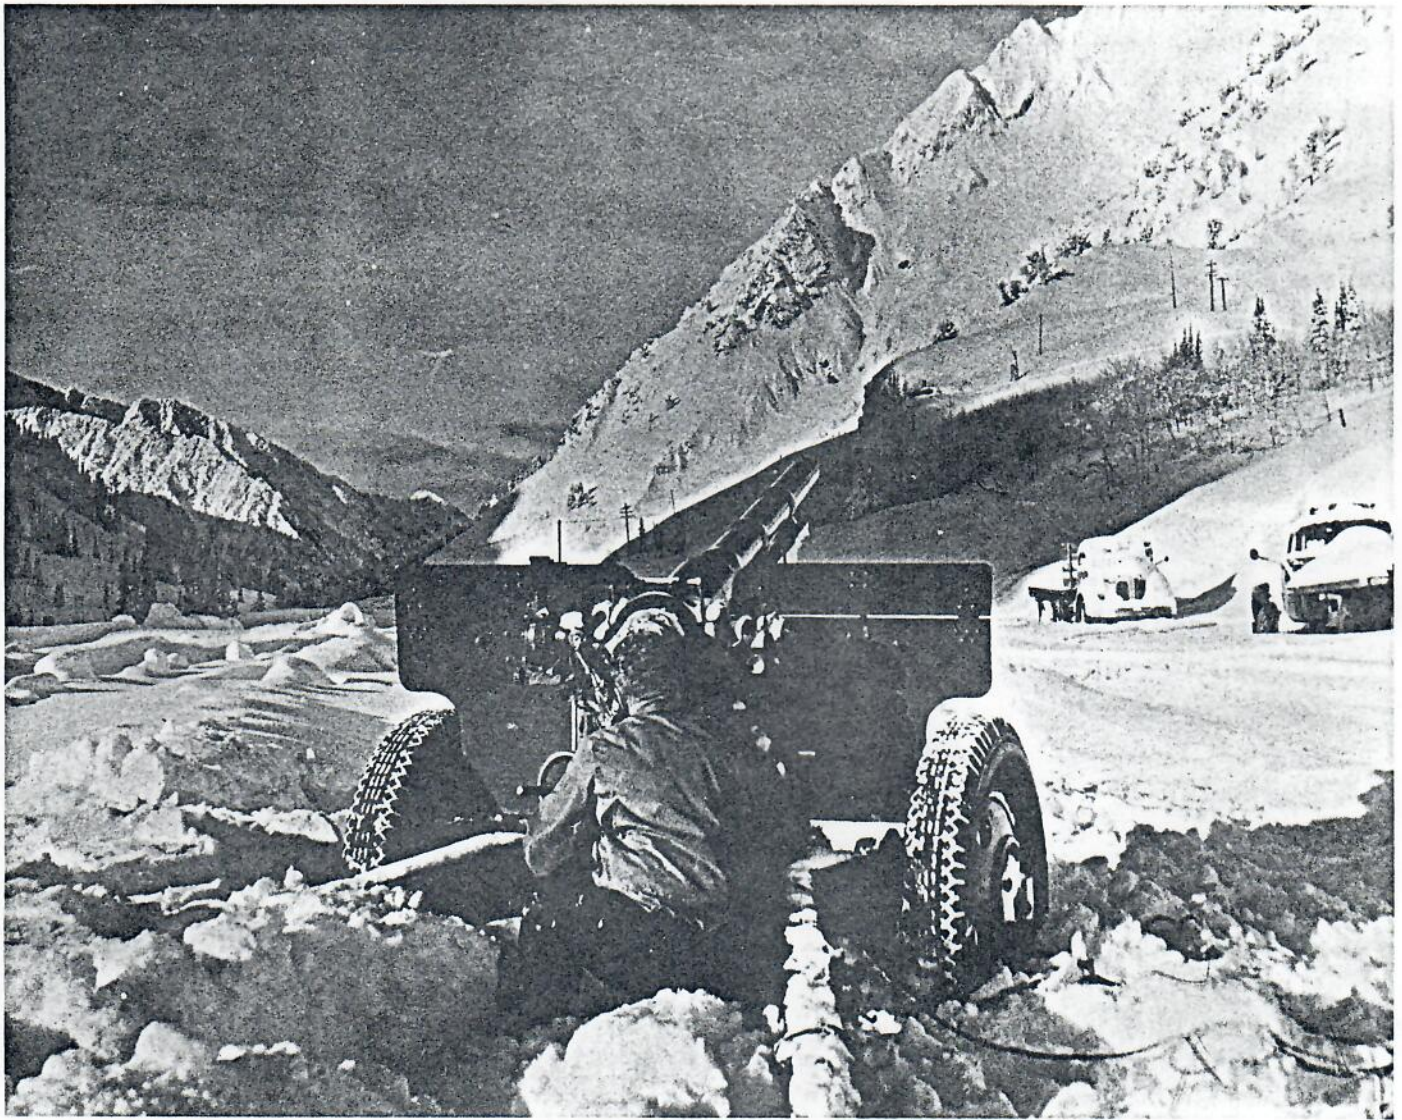
Figure 19.—Snow ranger aiming howitzer at avalanche area on flank of Superior Peak, Alta, Utah. Little Cottonwood Canyon is beyond left edge of gun.

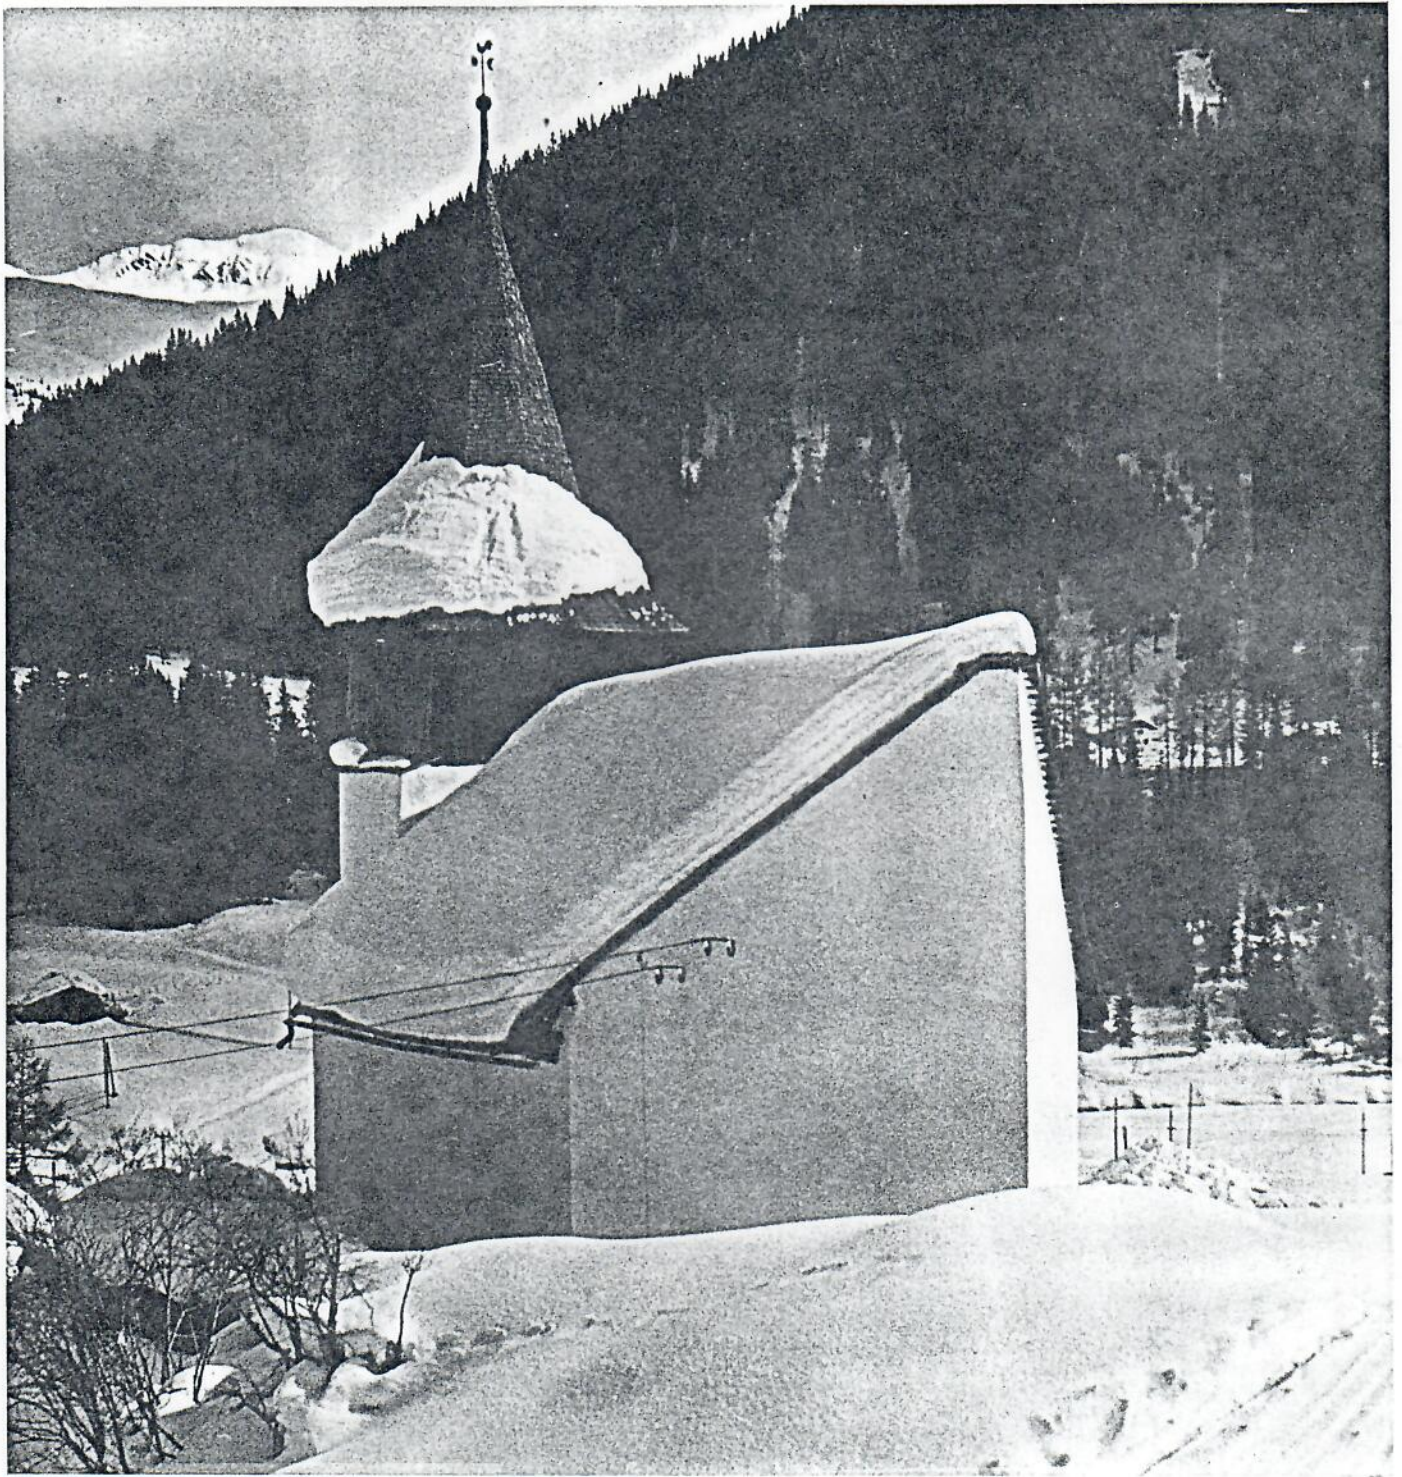
Figure 20.—Ancient Swiss church, protected by an avalanche diversion wedge. Photo, courtesy of E. R. LaChapelle.

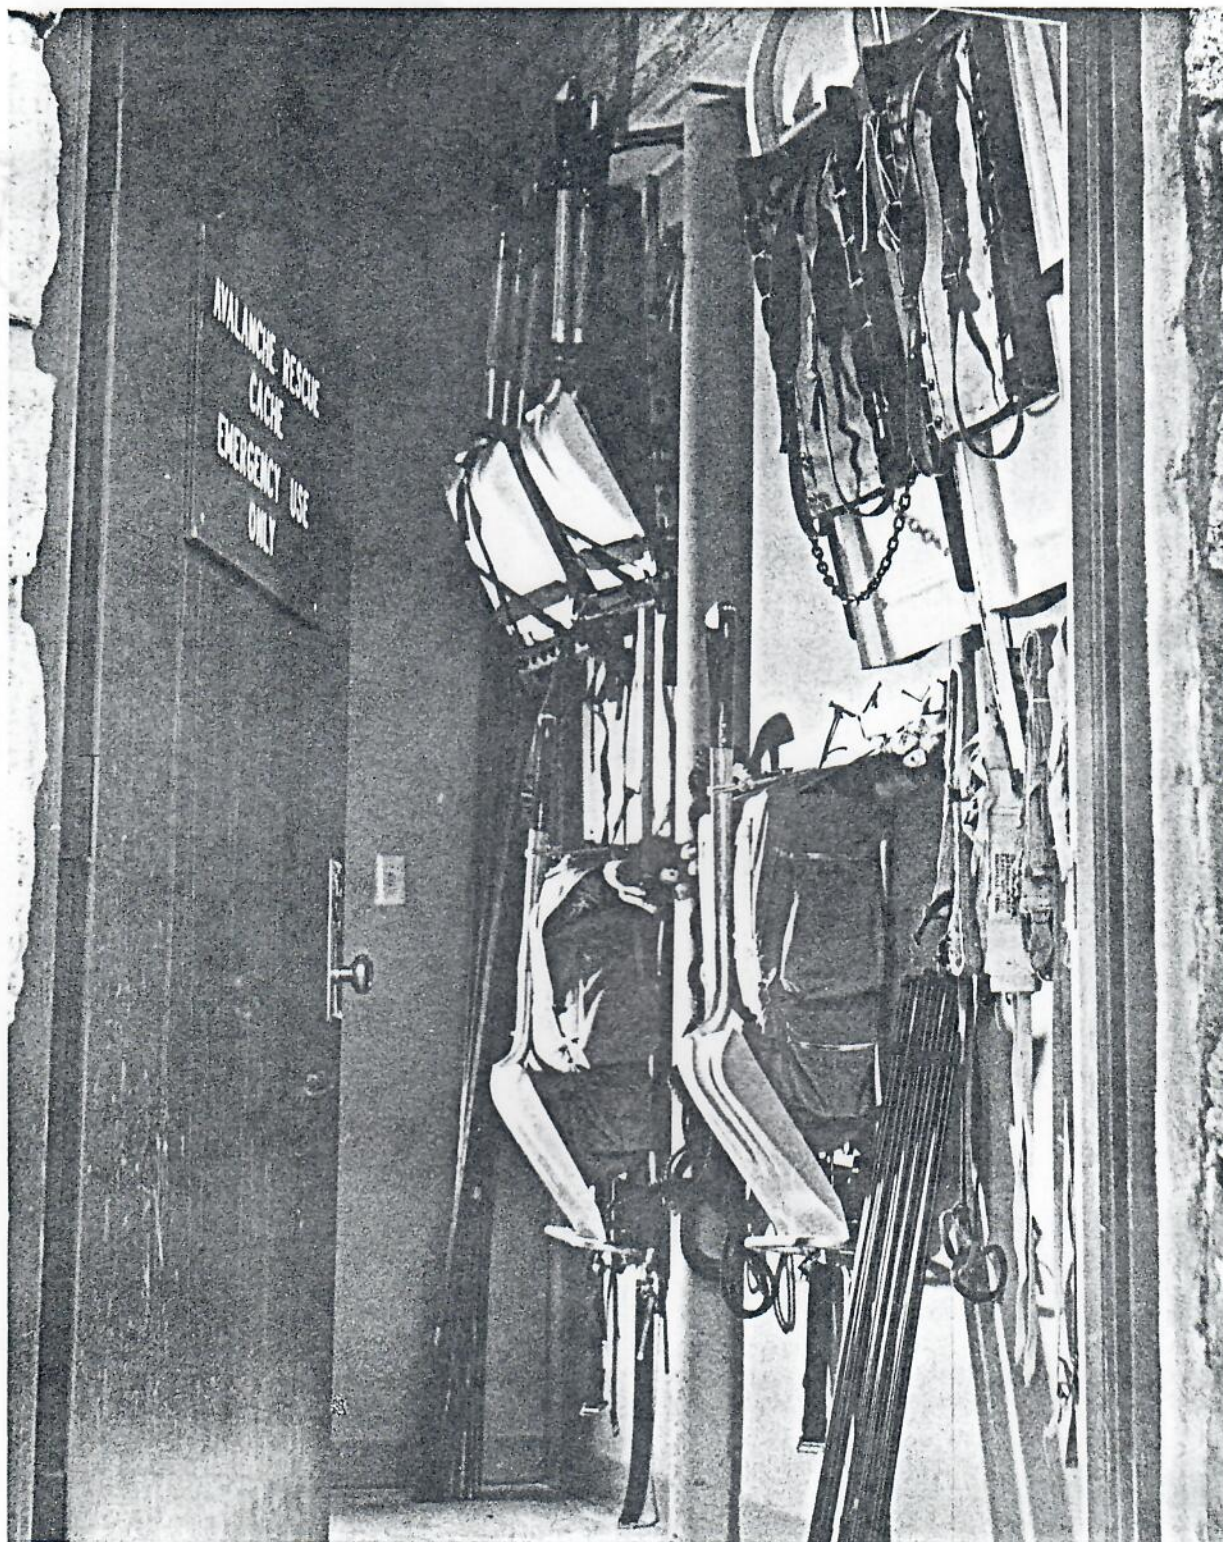
Figure 21.—U.S. Forest Service avalanche rescue cache, Alta, Utah. Cache includes probe poles, shovels, first aid set, and rescue sled.

When all preventive measures have failed, final protection is provided through avalanche rescue. In spite of the equipment (fig. 21) that is available and the manpower that rallies to the distress call (fig. 22), avalanche rescue

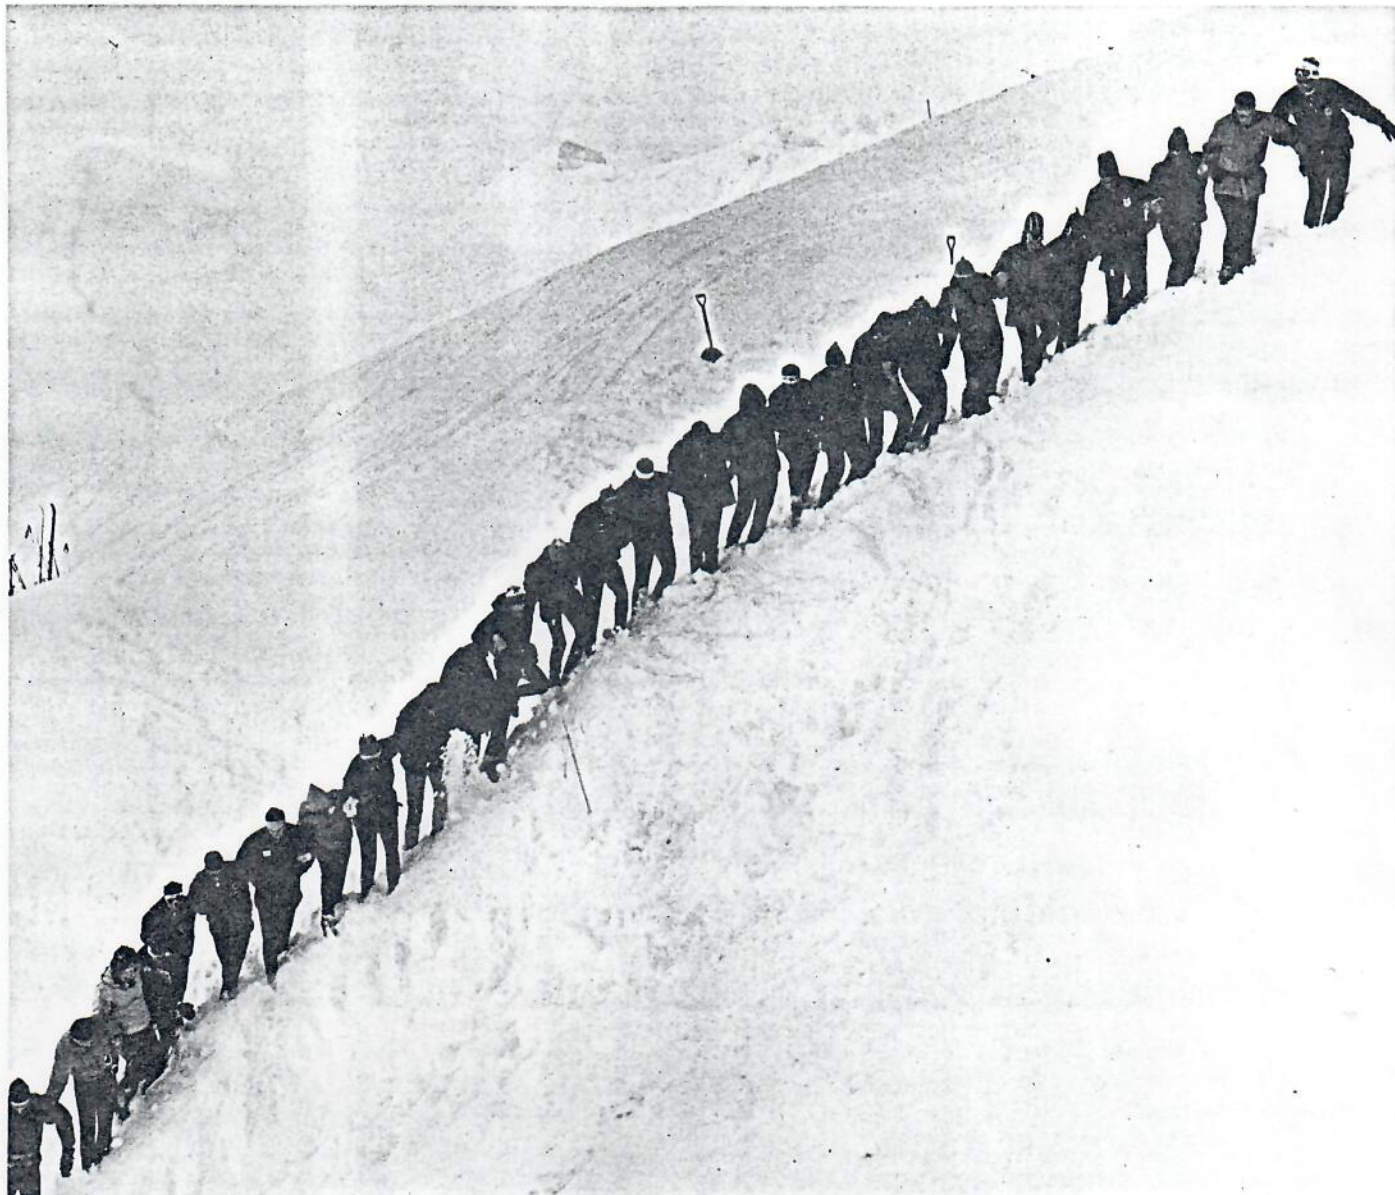
Figure 22.—Part of human chain from a mountain community making a rapid and preliminary search for surface clues to avalanche victims while awaiting arrival of long poles for probing. Only 20 percent of completely buried victims survive.
